Consolidation Coal Emery Mine Subsidence Report for May 2007

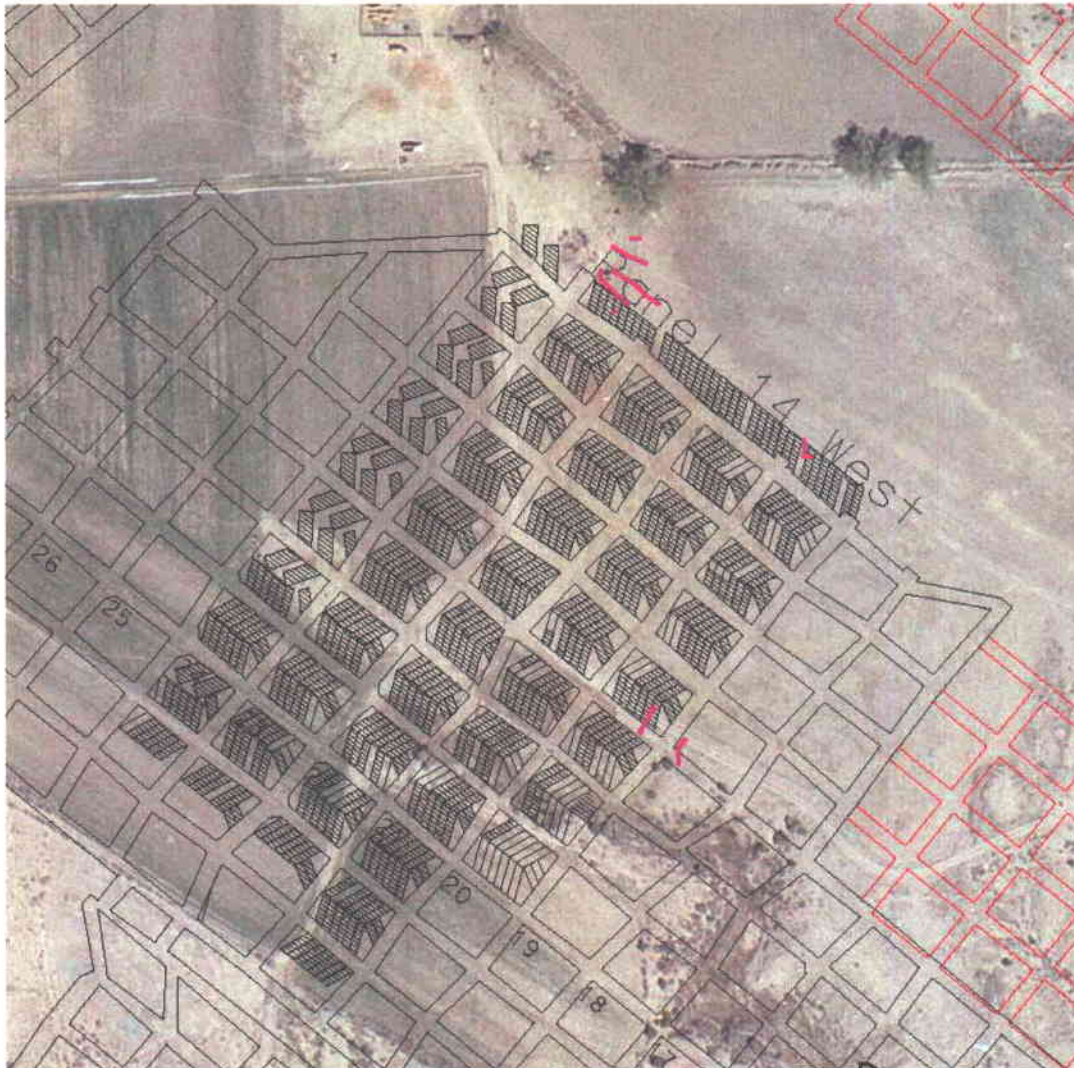
6-8-07

- 5-8-07 No subsidence noticed over Panel 14 West. PB
- 5-19-07 No subsidence noticed over Panel 14 West. PB
- 5-21-07 No subsidence noticed over Panel 14 West. PB
- 5-31-07 Subsidence noticed over Panel 14 West. PB
- 6-4-07 1 inch cracks found above Panel 14 West where pillaring. Marked locations with GPS. PB

Few cracks over Panel 14 West pictures were taken. PB
